Field Report for Airborne Data Collected In Support of US EPA Region 6 South 4 Group Fire 07 December 2019

Flight Results for Flight 19, 07 December 2019

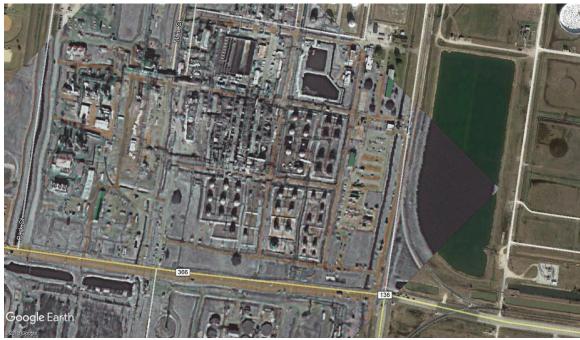
Figure 3: – 3 band IR image, Flight 19, Run 5, South 4 Group Fire

A total of 1 test and 9 data collection passes were made in the proximity of the facility and an infrared line scanner image was generated for each pass. Figure 3 shows a typical 3-band infrared image obtained from data collected for Run 5. The image shows a flat thermal environment for the process unit other than heating due to solar radiation. No plume is present in the image. To assess possible oil sheen presence on the Naches River and a nearby drainage channel, ASPECT collected IR data along the drainage waterways; no oil sheen signatures were detected (figures 4 and 5).

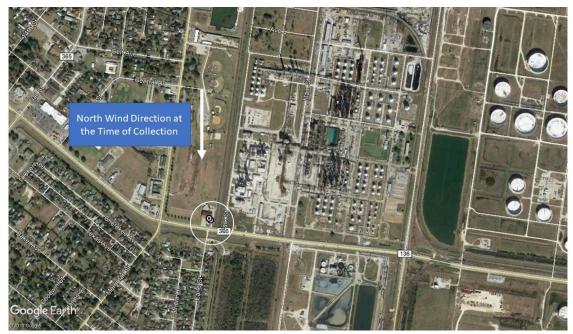
Figure 6: -- Isobutylene Detection, Flight 19, Run 3, South 4 Group Waterway Image

On data collection Run 3, isobutylene was detected at a maximum concentration of 1.63 ppm about 550 meters Southwest of the facility (figure 6). At the time of collection, winds were from the North. To further assess this detection, a line was flown between Run 2 and Run 3 which showed no detections. The wind direction during this collection was also from the north. A summary of data of the data collection is given in table 3.

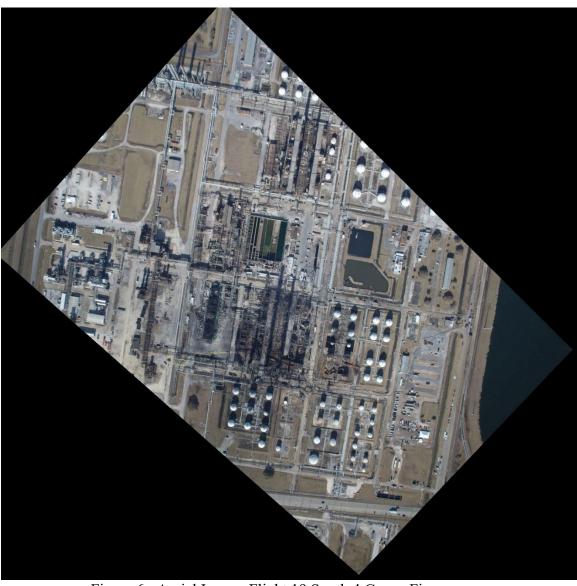
Figure 6: Aerial Image, Flight 19 South 4 Group Fire.

A full set of high resolution aerial digital photography were collected as part of the flight. Figure 7 and 8 show representative views of the process unit. No emissions are visible in these images. In addition, the images and crew reports indicated that no water cannon was in use.
